M  
Management Plan (EMP) of Karjan - Borsad, SH 3  
Road & Building Department, GoG

## ENGINEERING CHARACTERISTICS

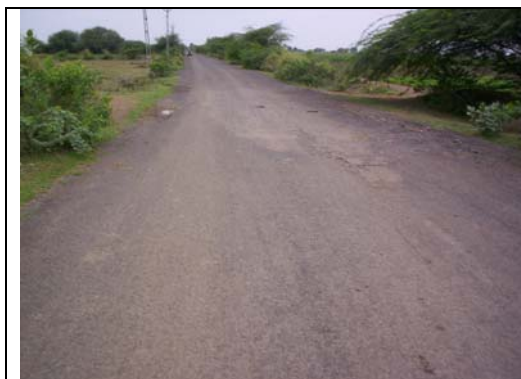
**Cracks & Settlements Km 47+150 (SH-06 )  
Borsad-Gamdhira Bridge roda**

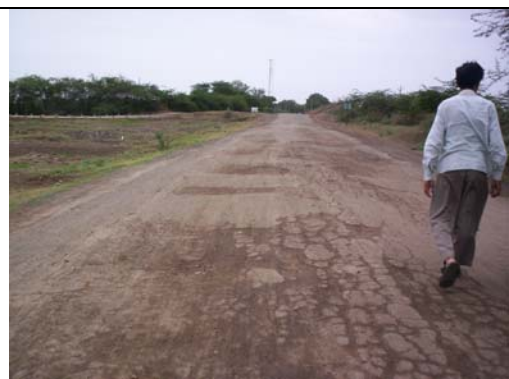
**Block cracking Km 14+775 to14+875  
(SH-160) Padra-Karjan roda**

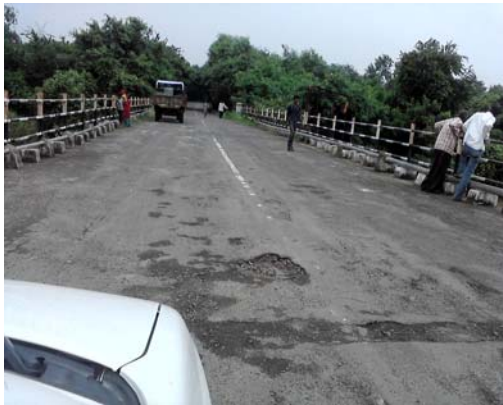
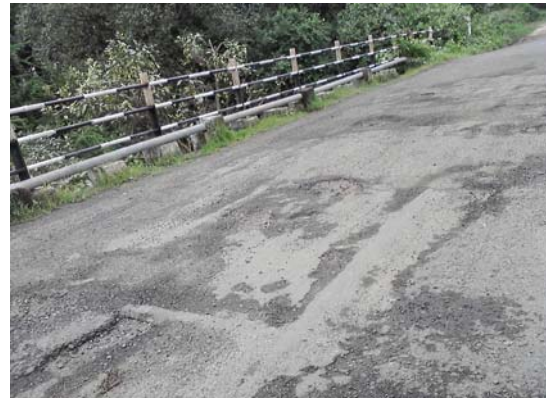
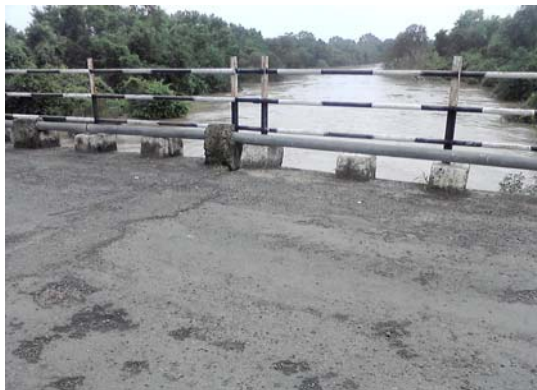
MJBR on river Dhaddar Km ch 14+200

Sr. No	Chainage (km)	Structure Number/ River Name	Type of Bridge	Nos. of span	Span length (m)	Total Length of Bridge (m)	Total Width of bridge (m)	Carriageway Width (m)	Structure Condition
1	14+200	-- 'KOTHWADA' / dhadhar	Solid Slab	3	15.30	50	7.50	6.90	1. VEGETATION 2.LHS & RHS BED APPRON DAMAGED
2	10+350	-- 'ON VISHVAMI TRI RIVER'	Solid Slab	2	10.0	45	7.50	6.85	1. UNDER CONSTRUCTION (Before this was as a Minor bridge)
<b>SH – 06, MAHUVAD CHOKADI TO GAMBHIRA BRIDGE (MUJAPUR) ROAD, Km 00+00 to 4+240</b>									
1	3+200	'ON MAHISAGAR RIVER'	Solid Slab	21 2	37.75 33.00	832	7.50	6.90	1. VEGETATION 2.Top wearing coat need
<b>SH – 06 Borsad-Gamhira Bridge Road Km-35+585 to 56+555</b>									
3	51+965	-- 'LOCAL NALLA'	Solid Slab	2	20.00	46.00	9.70	6.85	1. VEGETATION 2. PARAPET OF BRIDGE DAMGED 3.THREE JOINTS ARE OPENED 4.LHS & RHS PIPE RAILING TOTALLY DAMAGED

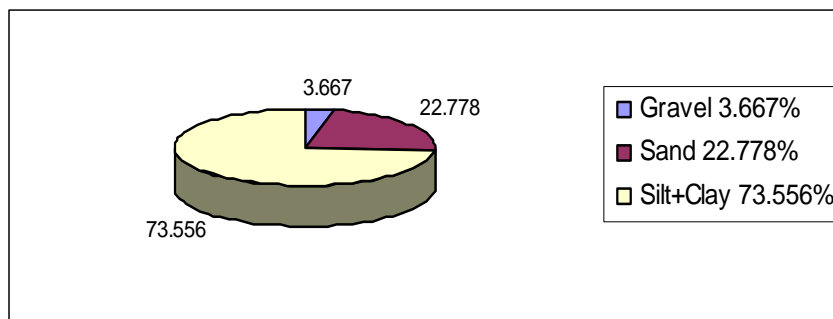
Figure 1.1: Distribution of Sub grade Soil (Major Pits) type along the Project Corridor

Total thirteen samples have been collected and tested for grain size analysis and Atterberg's limit. Out of thirteen samples received from trial pits, three samples belong to Clayey Sand Classification (SC) and ten sample belongs to Clayey Soil Classification (CH) type. Percentage distribution of each type of existing sub grade soil along the project corridor is shown in Figure 1.1.

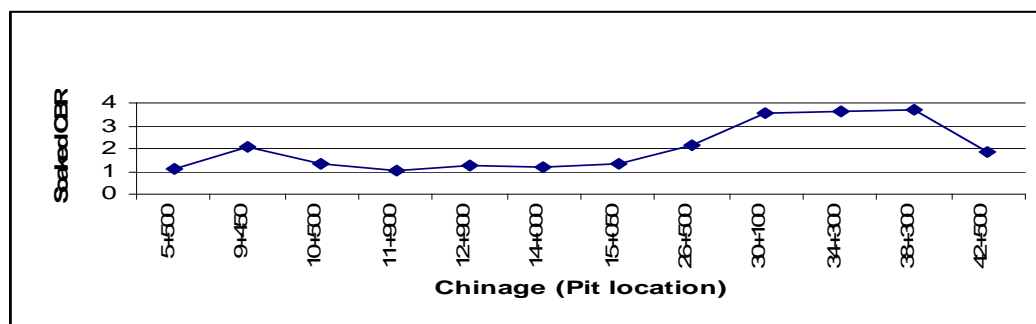
Figure 1.2: Value of CBR % along the Project Corridor

The 4-day soaked CBR value at 97% of MDD of sub-grade samples varies from 1.1% to 3.71 %.

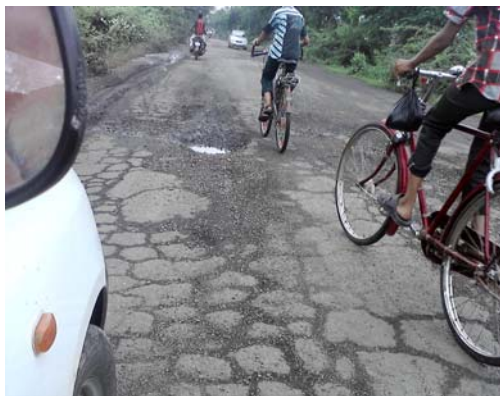
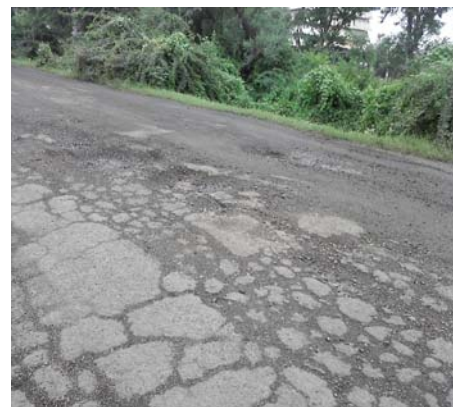
Crackes and pot holes seen on road of Padra Karjan		Crackes and pot holes seen on road of Padra Karjan
--	--	--
